# Crash of the Polish Governmental Plane PLF 101 in Smolensk<sup>1</sup>

**April 10, 2010**

Status Report Dated November 11, 2011<sup>2</sup>

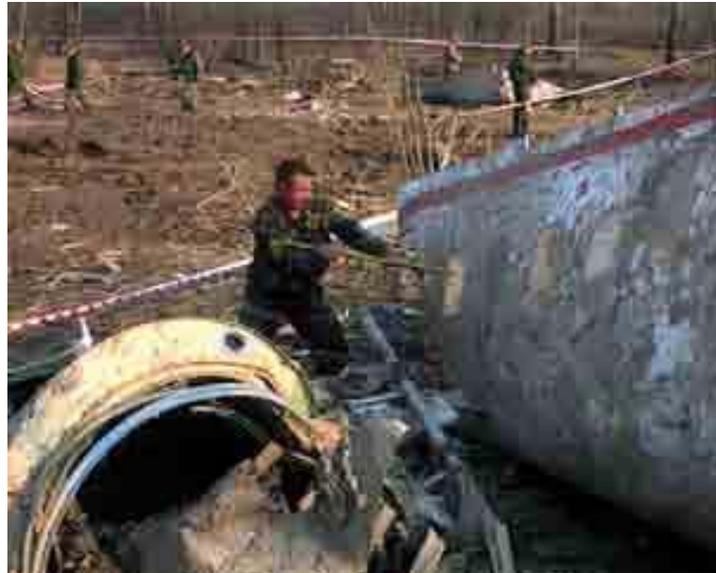
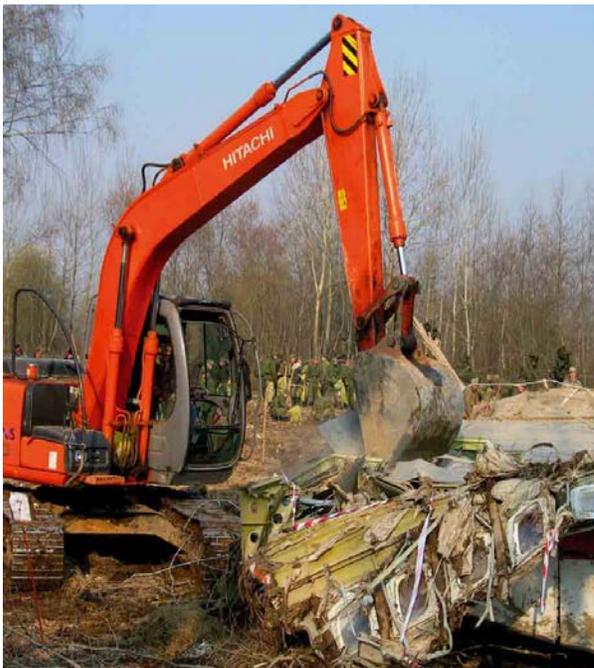
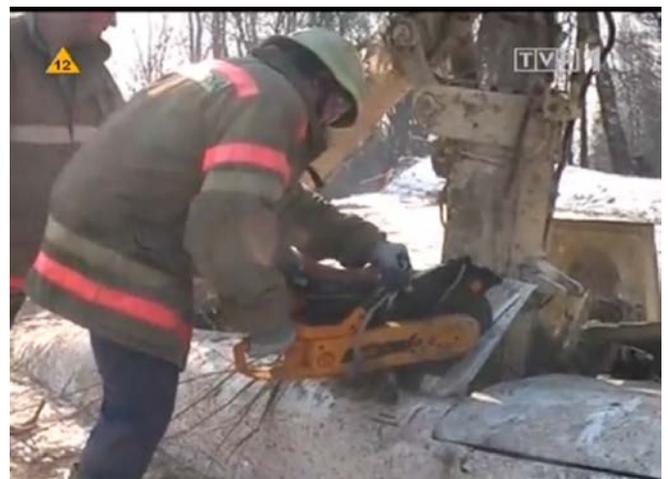
## Appendix 1: Destruction of Evidence

### Photos Taken at the Scene of the Smolensk Crash on April 11, 2010<sup>74</sup>
